Manhole Inspection Summary

Manhole # S06CC2007MH

Location Address: **3711 KINGSWOOD SQ**

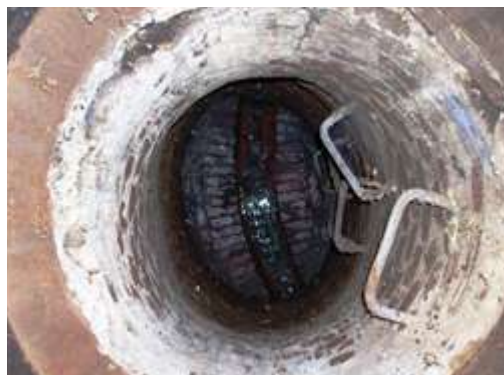
Top View

Evidence of surcharge - Bench debris.

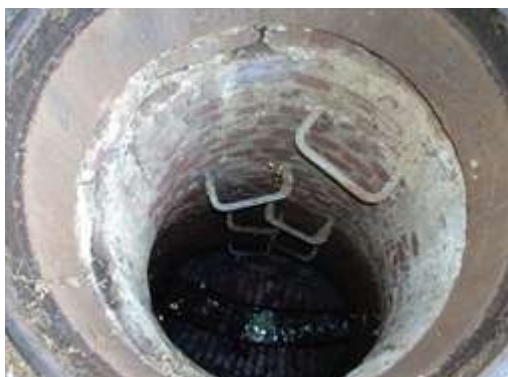
Defect

Frame leaks. Adjustment deterioration and loose brick. Adjustment and Barrel infiltration - other side.

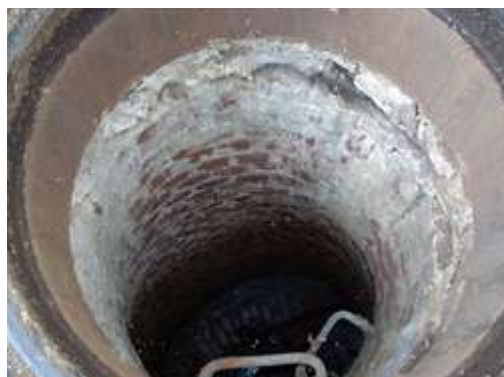
Defect

Frame leaks. Adjustment deterioration and loose brick. Adjustment and Barrel infiltration

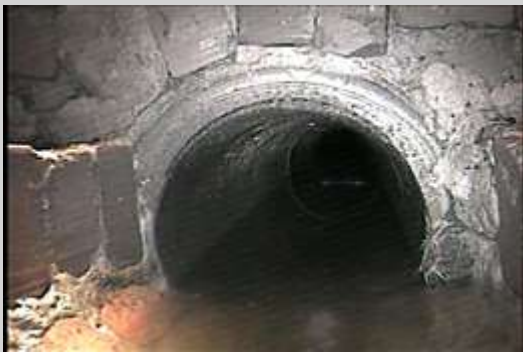
8 in. Circular Gravity Sewer Pipe Out @ 12 O'Clock

Deposits: ☐ None ☐ Mud ☐ Sludge ☒ **Debris** ☐ Grease

Infiltration: **Evidence** Pipe Seal Cond: **Roots**

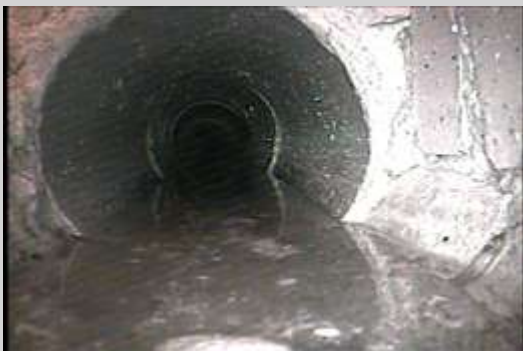
8 in. Circular Gravity Sewer Pipe In @ 5 O'Clock

Deposits: ☐ None ☐ Mud ☐ Sludge ☒ **Debris** ☐ Grease

Infiltration: **Evidence** Pipe Seal Cond: **Cracked**
